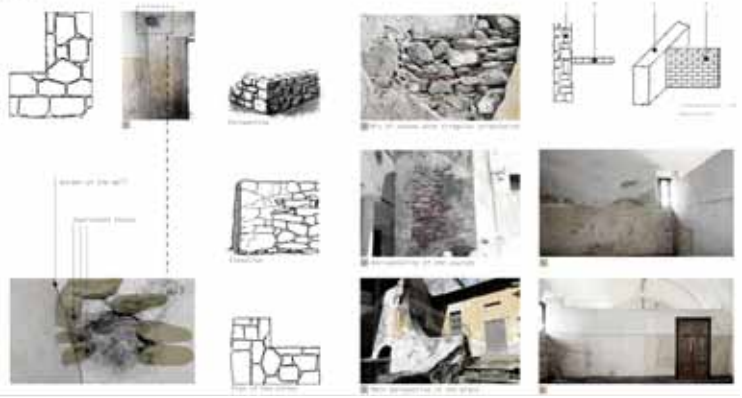
**1. Evaluation of the existing**  
The diagram shows the reconstruction of the area, on the lateral corner of the road on the ground floor, stone and perforated path remains a strong and effective with connection.

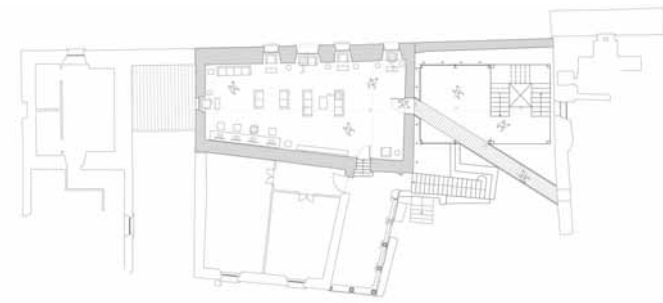
**3. Reconnecting**  
From the program and diagram it is possible to visualize the integration of the lateral built brick wall and the existing one connected by stone masonry.
