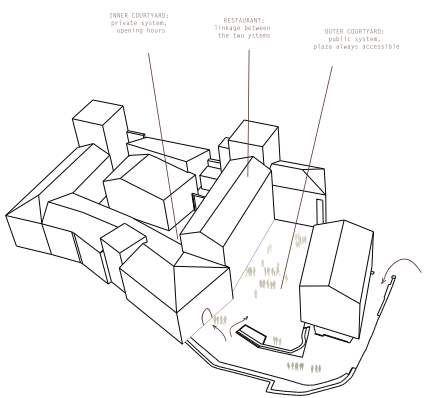
**1. Evaluation of the existing**  
The diagram shows the reconstruction of the area, on the lateral corner of the road on the ground floor, stone and perforated path remains a strong and effective with connection.

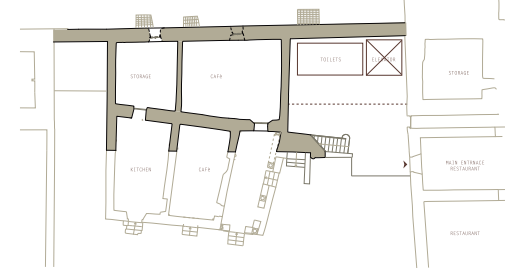
**2. Storage capabilities**  
Stone masonry, of irregular shape, with different diameters, densely arranged in horizontal courses with staggered joints and with wide spaces. The horizontal mortar joint is approximately 2 cm, in grey colour.

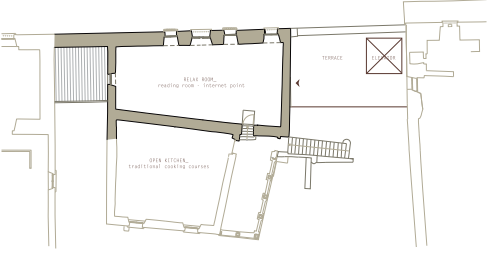
**3. Reconnecting**  
From the program and diagram it is possible to visualize the integration of the lateral built brick wall and the existing one connected by stone masonry.
